C Technical Report 516

COMPOSITE-UNIT ACCELERATED LIFE TESTING (CUALT) OF SONAR TRANSDUCERS

DL Carson et al

September 1979

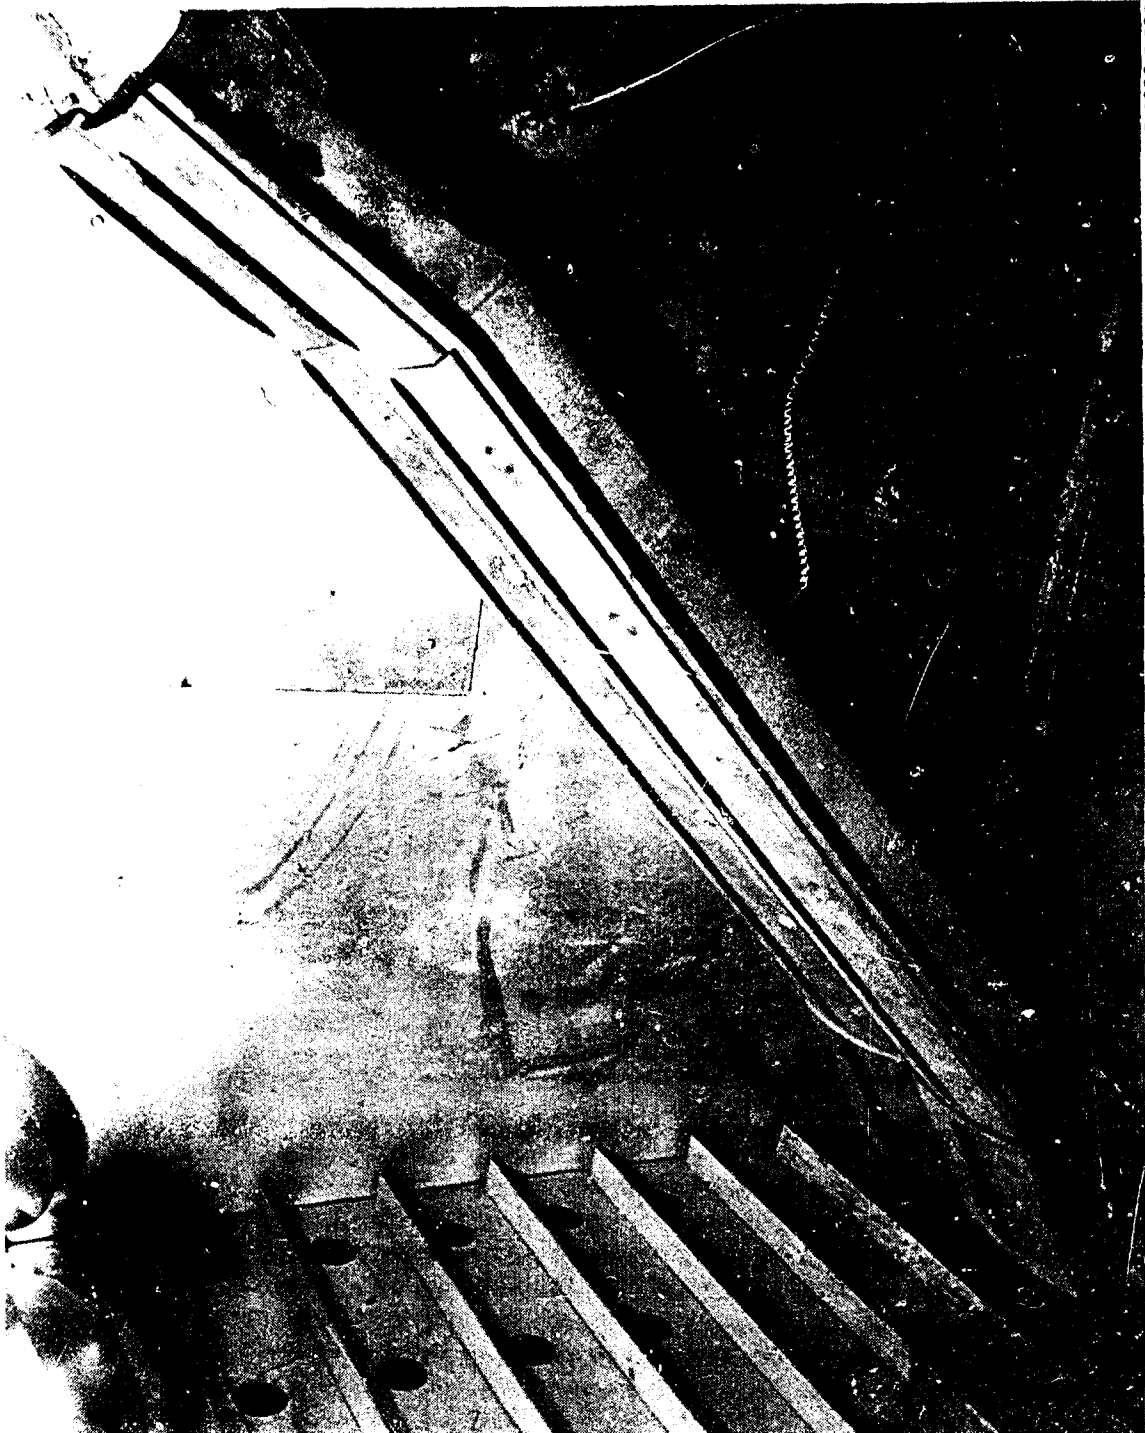
Figure 6-2. Rubber Window Bulges Due to Heat

During stress exposure 5 (thermal shock) it was found that more bulges remained in the rubber windows of T2N and T2U (marked with O). Immediately after SE5, air was confirmed as described later with stethoscope probes and an air removal syringe. It was also found upon disassembly that the pressure

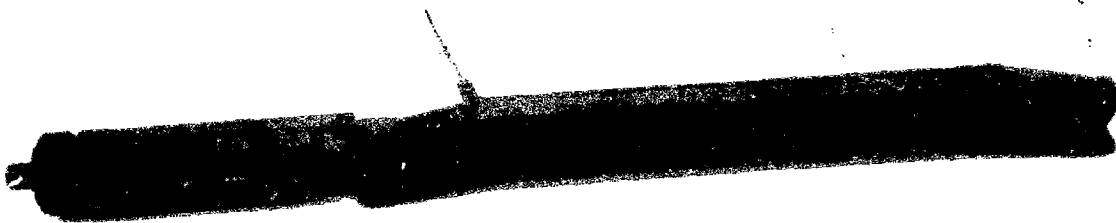
Figure 6-4. Device Used to Detect Air in Transducer

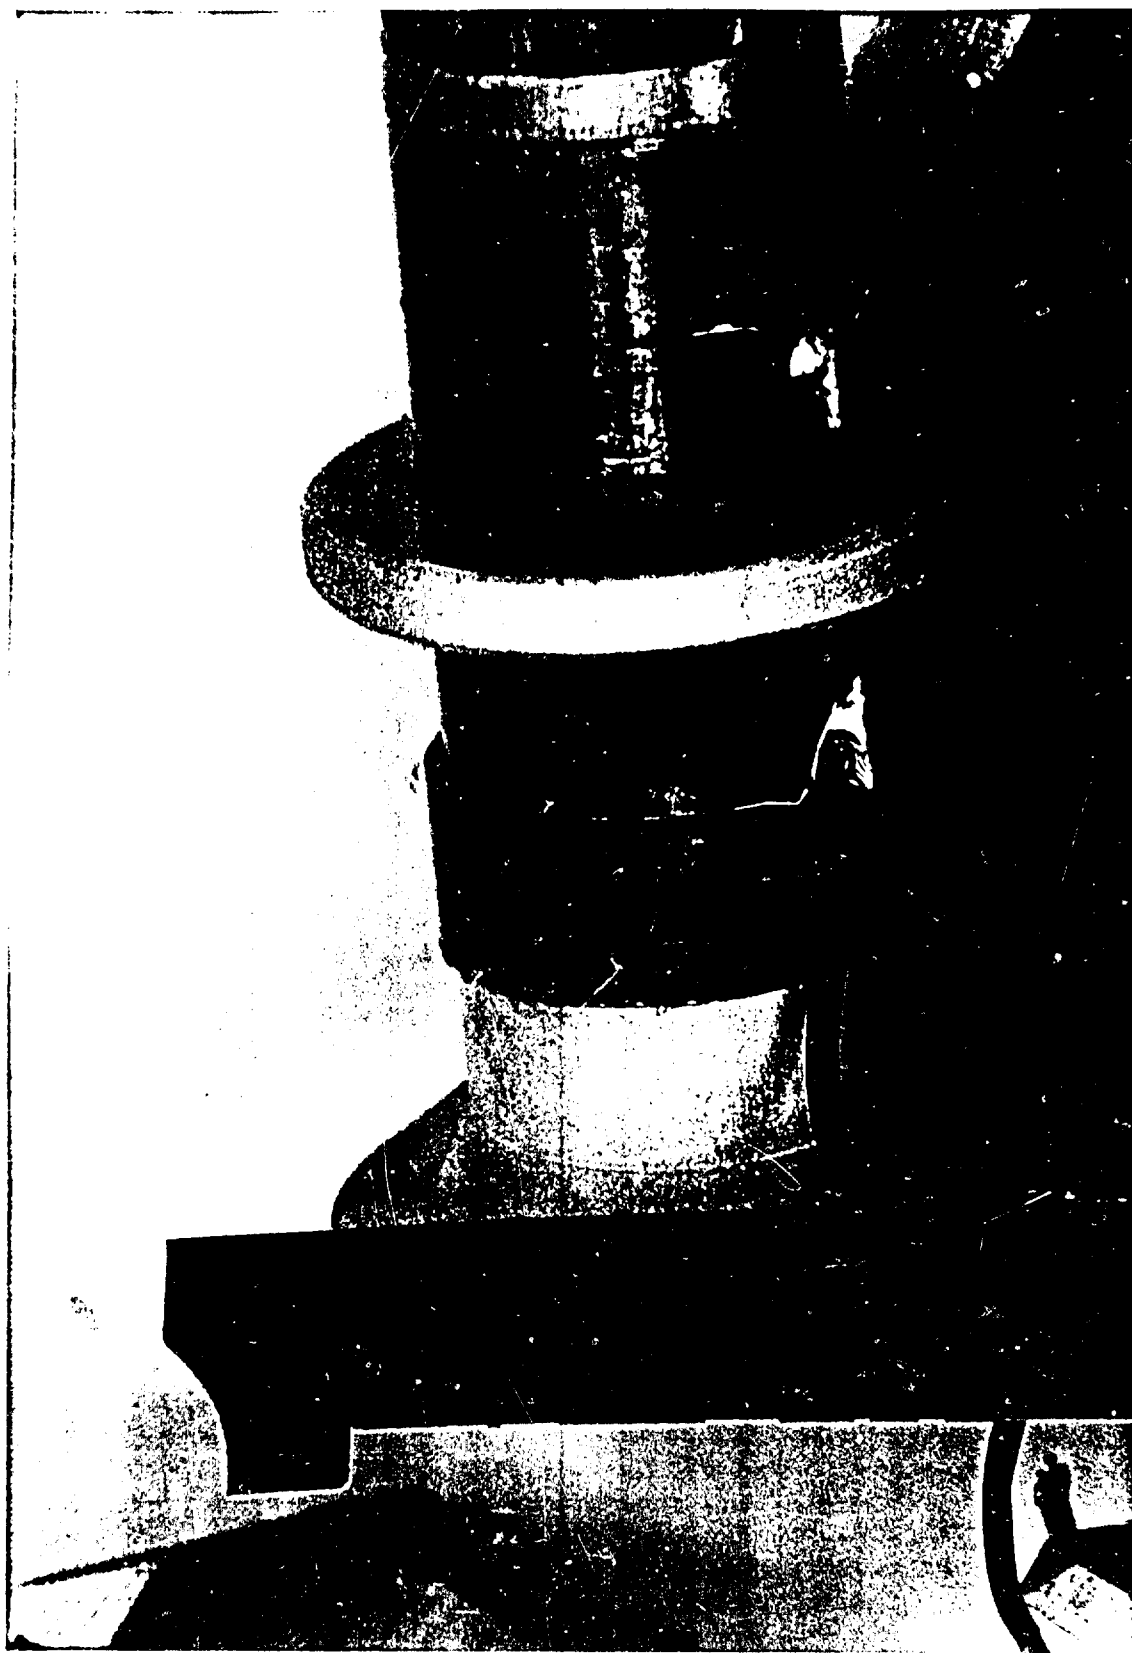
Figure 6-9. Cracked Ceramic Stack and Bent Electrodes

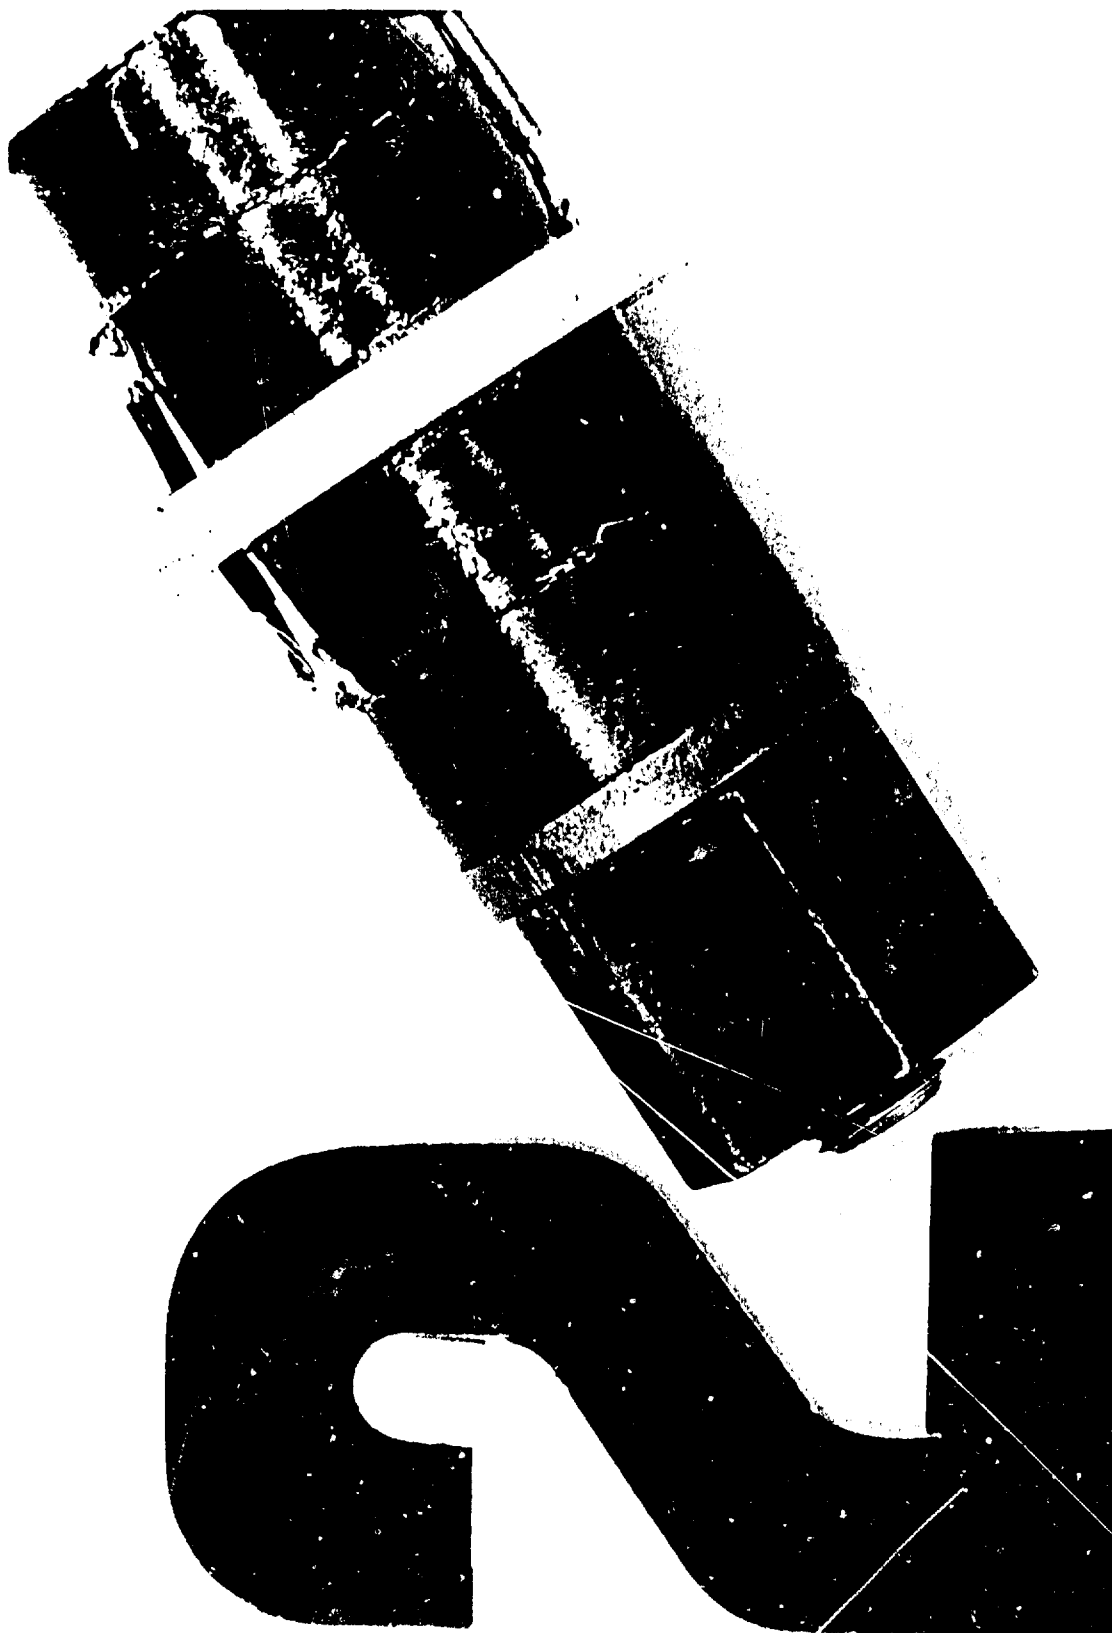
Figure 6-13. Insulation of Wires Cut Short and Cold Soldered Connection Failure
